# San Fernando, California, Earthquake of February 9, 1971

U.S. DEPARTMENT OF COMMERCE  
National Oceanic and Atmospheric Administration

*Part B. Buildings continued; Soils and Foundations*

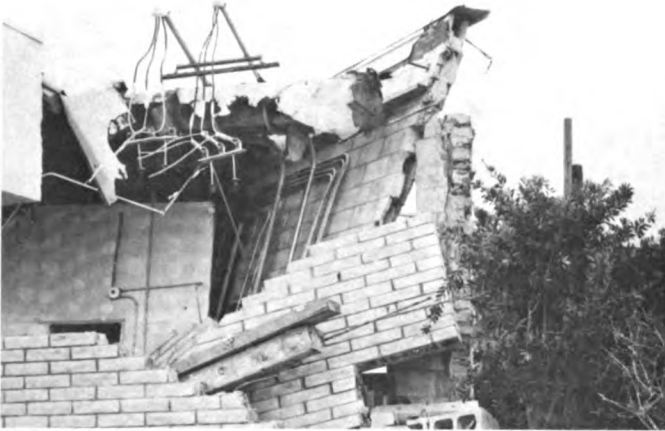
*Figure 2.—Stone's Liquor Store. Concrete block wall at southeast corner of building.*

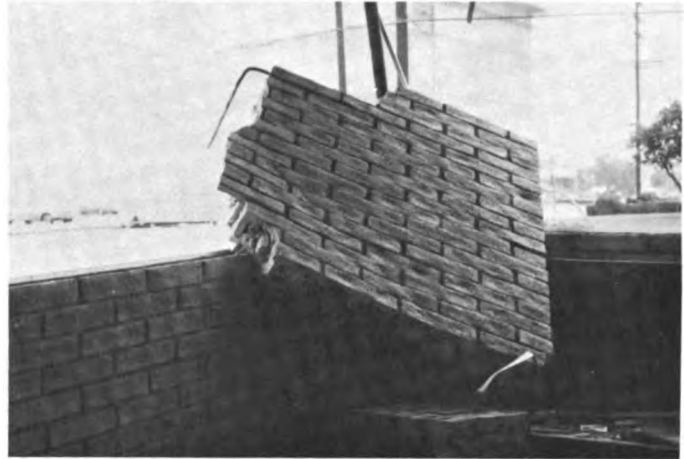
*Figure 4.—Stone's Liquor Store. Remains of short shear wall located at southwest corner of building.*

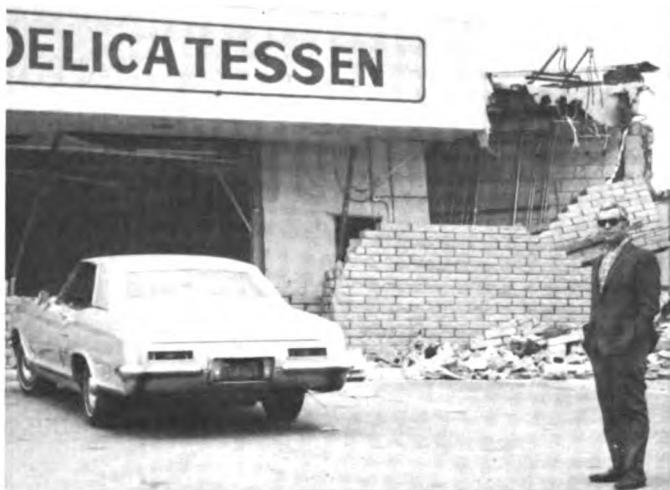
*Figure 3.—Stone's Liquor Store. Southeast corner of building. Bent steel pipe column can be seen to the left of collapsed pier.*

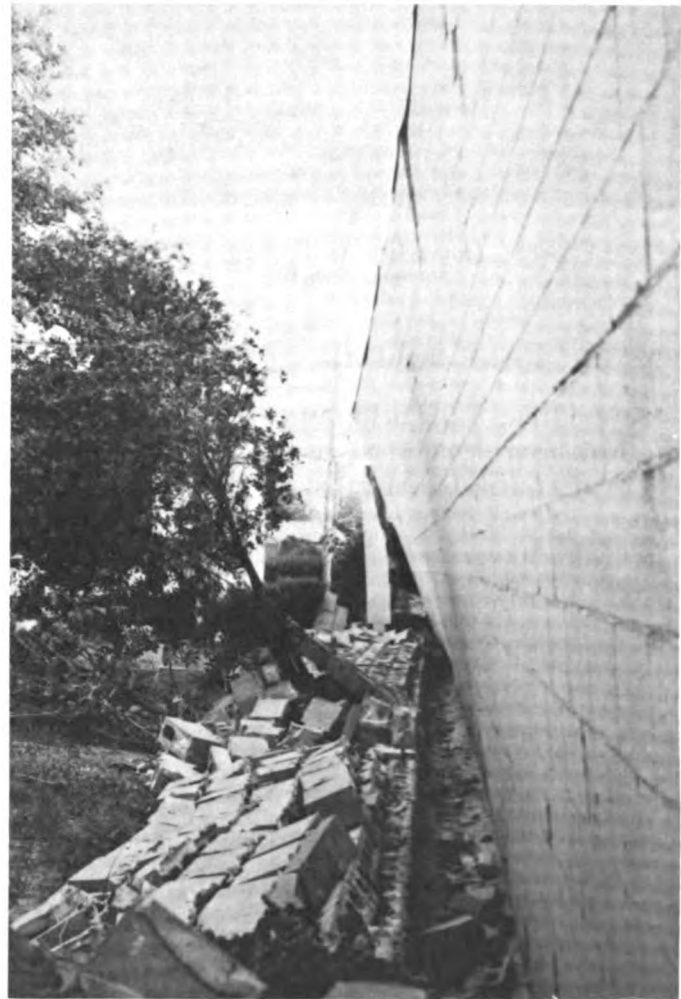
*Figure 5.—Stone's Liquor Store. East wall of building. Apparently, an adjacent and much shorter block fence wall was knocked down by taller building wall.*

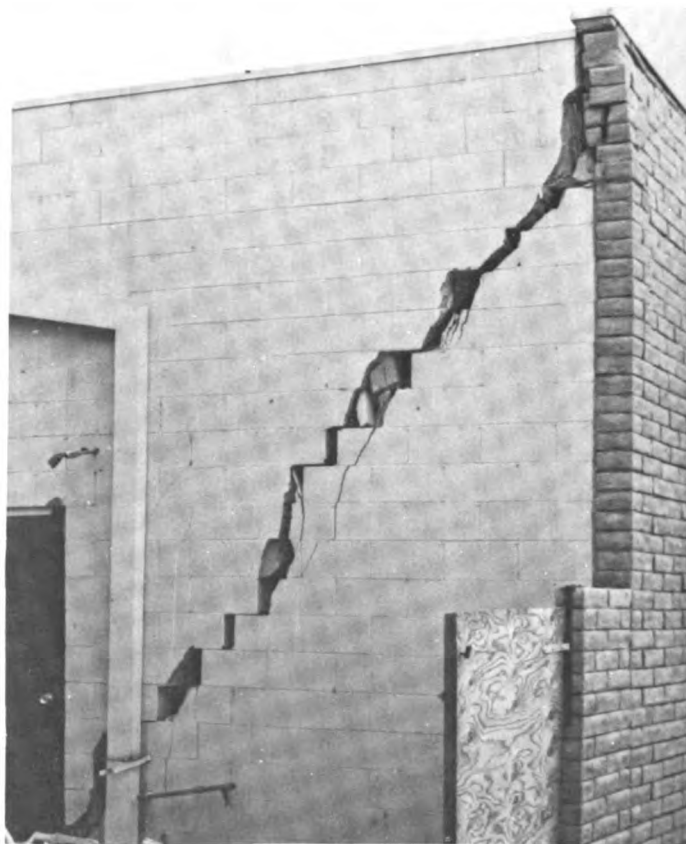
Figure 7.—Stone's Liquor Store. North concrete block wall severely cracked.

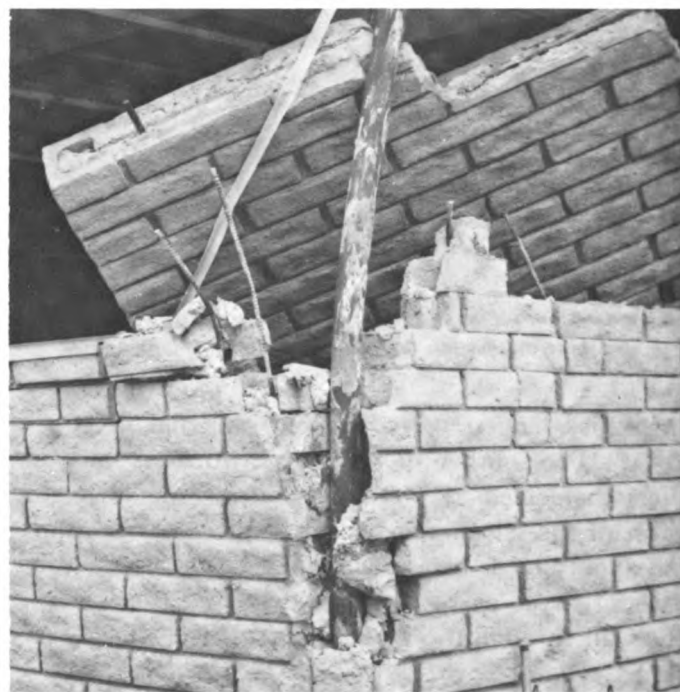
Figure 8.—Stone's Liquor Store. Southwest corner of building. Collapsed shear wall and bent steel pipe column enclosed within wall.

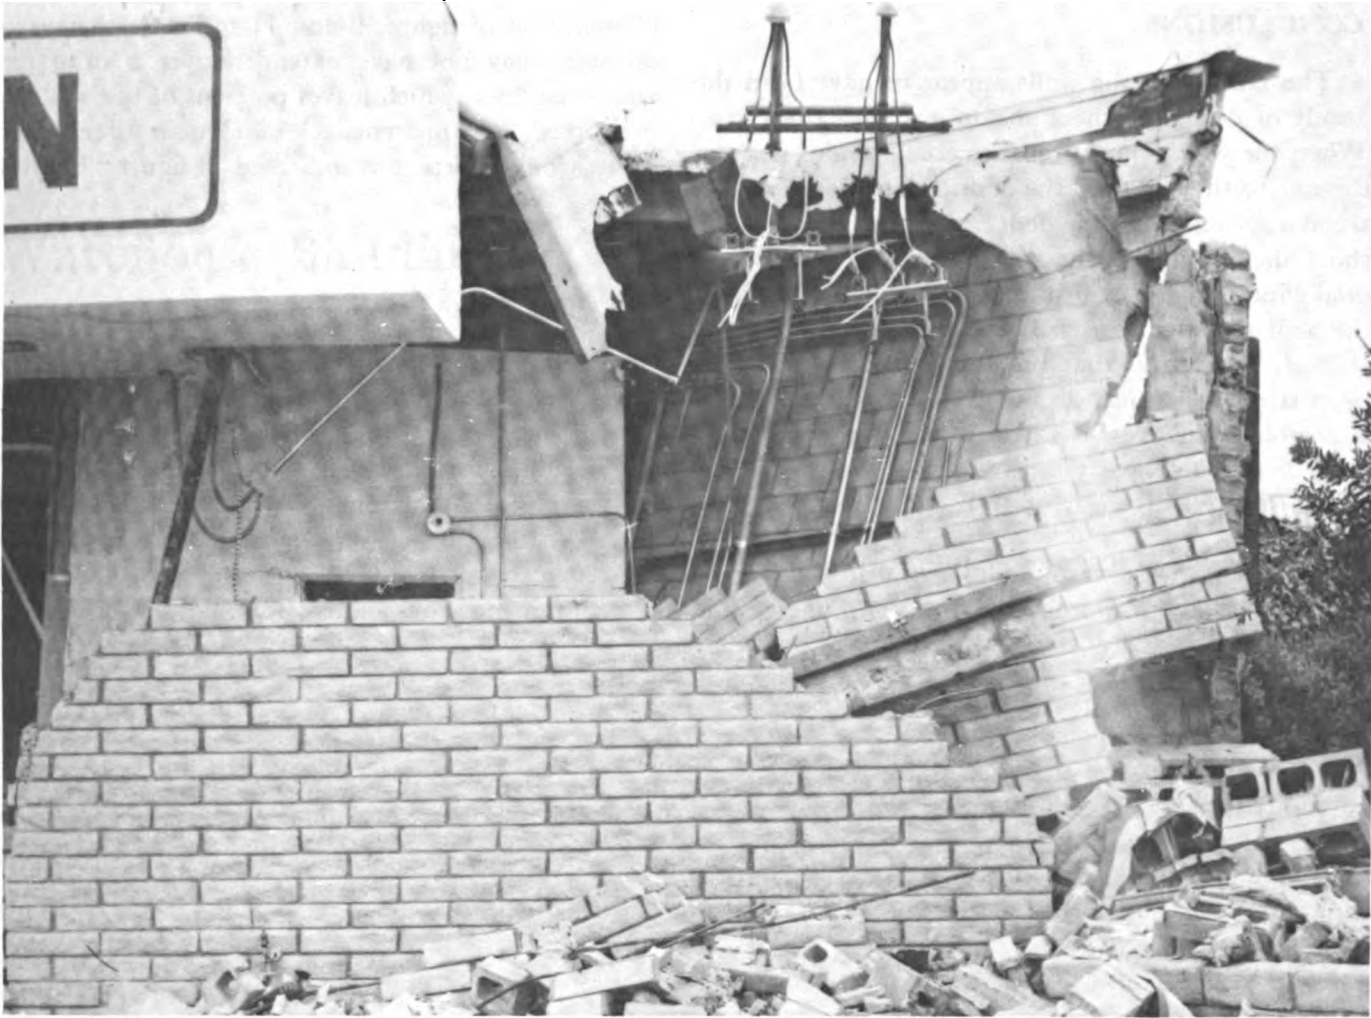
Figure 9.—Stone's Liquor Store. Collapsed shear wall at southeast corner of building.

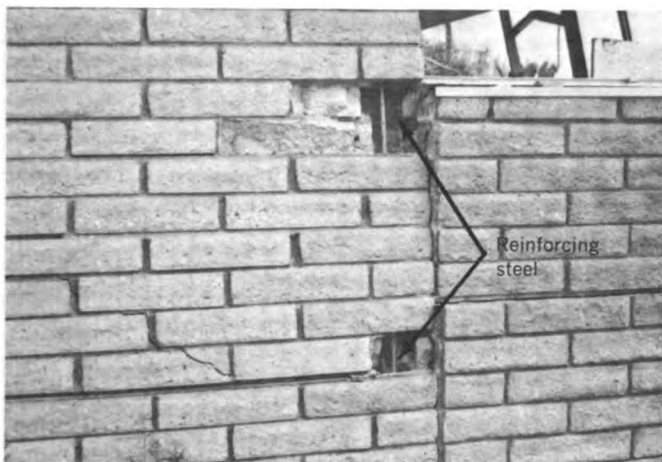
Figure 10.—Stone's Liquor Store. Cell with reinforcing steel does not appear to contain grout.

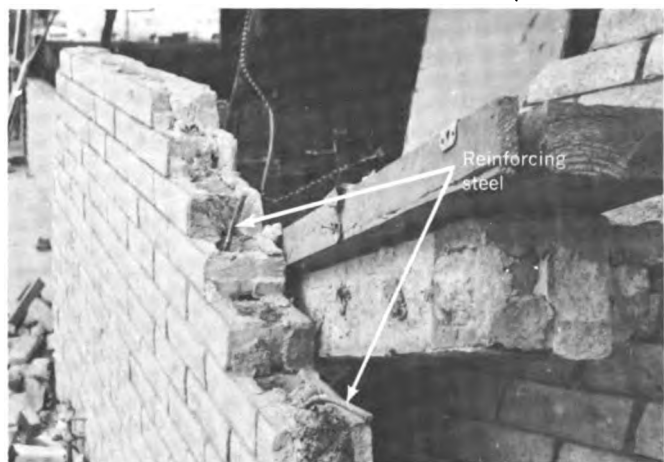
Figure 11.—Stone's Liquor Store. Collapsed full-height wall shows upper end of reinforcing steel. Lack of grout in cell with reinforcing is also apparent.

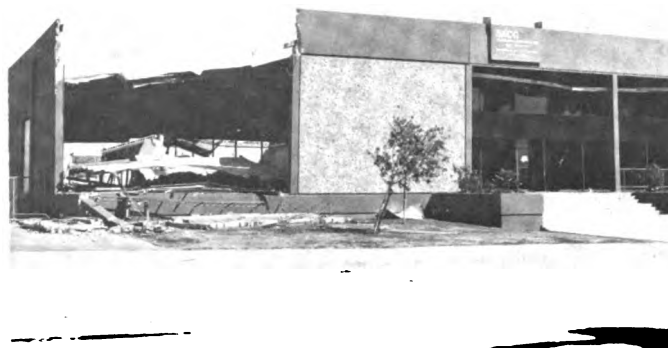
Figure 2.—Warehouse Building. Concrete beams and column framing at northwest corner of the building collapsed. Note broken glass in entrance area. Los Angeles City Department of Building and Safety photograph.

the building were broken; frames and mullions jammed and buckled (fig. 2).

ments severely damaged. Steel gusset plates were bolted to the glued laminated girders to reinforce the areas where cracking and separations occurred (fig. 3). Reinforced concrete that collapsed at the northwest corner of the building was repoured (fig. 4). Cracks in concrete were pressure injected with epoxy resin compounds, and almost every corbel had to be rebuilt after all of the affected concrete was removed (figs. 3 and 5). It is estimated that the cost of earthquake repairs was about \$80,000, which represents about 25 percent of the value of the building.

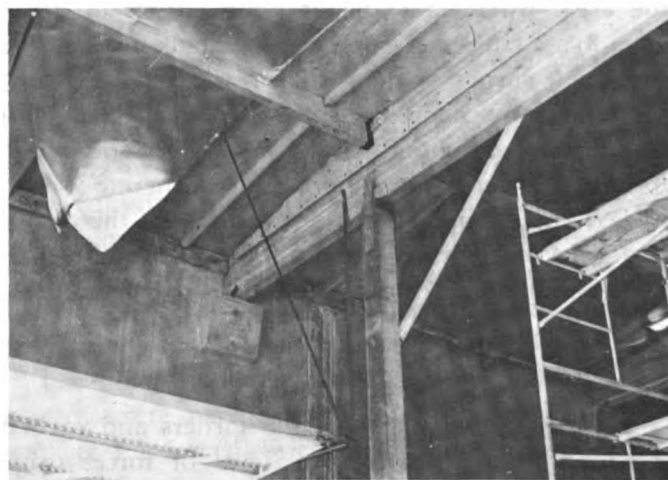
Glued laminated girders on line 2 (fig. 1) fell with the roof. Wall corbels supporting laminated girders were cracked, and the connection between both elements became ineffective. Several girders sustained either longitudinal cracks or partial separations of laminations.

Figure 3.—Warehouse Building. Glued laminated girder with gusset plate where split or delamination occurred. Repaired corbel on wall. Wheeler & Gray photograph.

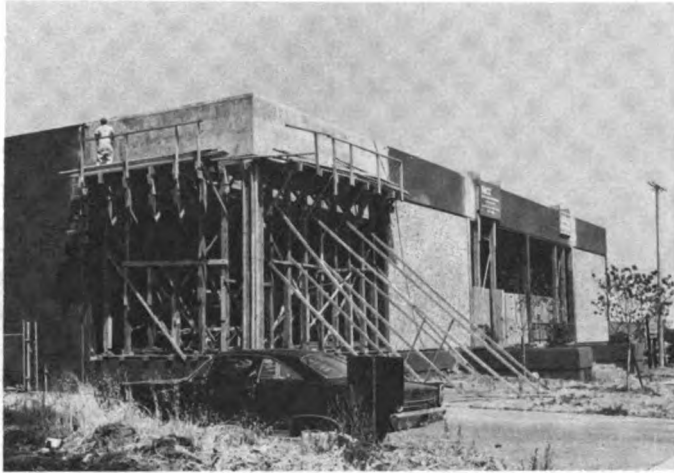
*Figure 4.—Warehouse Building. Reconstruction of reinforced concrete structure at northwest corner of building. Wheeler & Gray photograph.*

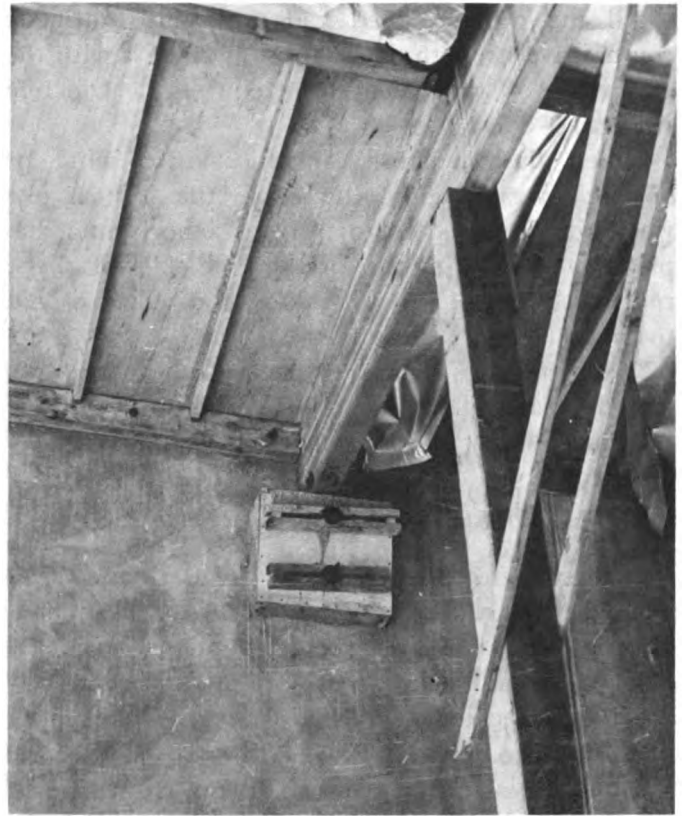
The connection between the girders and corbels consistently failed under the level of forces originated by this earthquake.

*Figure 5.—Warehouse Building. Wall corbels had to be repoured. Girder rests on temporary shoring. Wheeler & Gray photograph.*

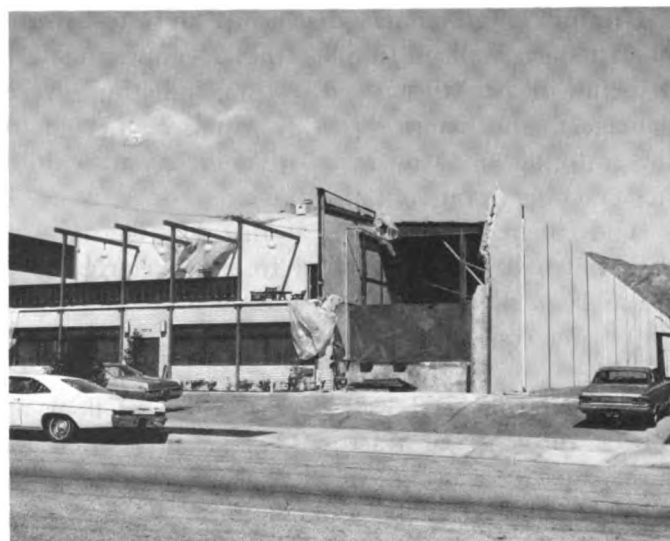
The east wall of the building and adjacent roof collapsed. The high west façade wall at the loading dock and the immediate roof supported by the wall also collapsed (fig. 4). It can be assumed safely that the roof sheathing and/or wood ledger separated from the wall at these areas. The walls and roof pur-lins lost their horizontal and vertical supports, respectively, with collapse of the wall and roof following.

Figure 4.—All Phase Color. West elevation of building. Precast concrete panel and adjacent roof collapsed. Los Angeles City Department of Building and Safety photograph.

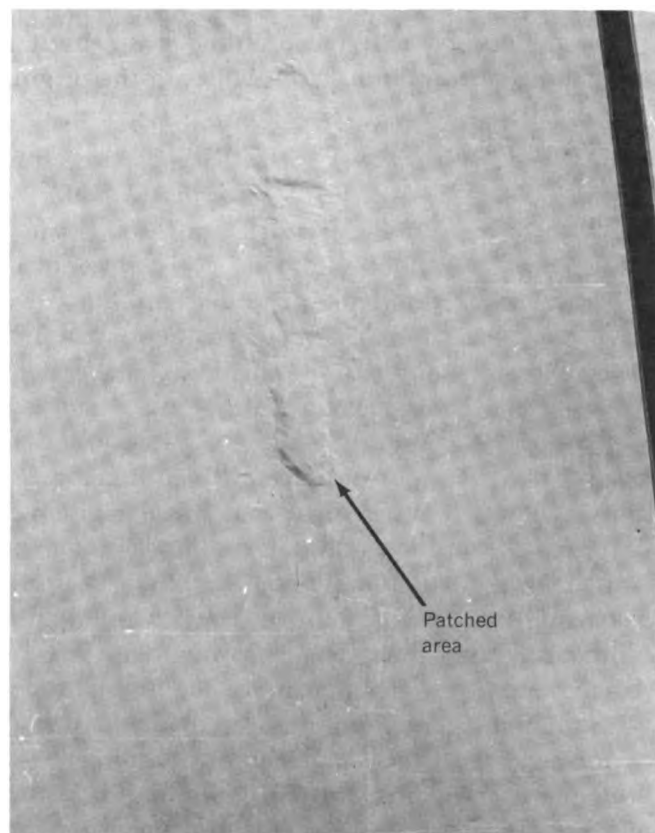
Figure 5.—All Phase Color. North wall, looking from outside the building. Though repaired, damage inflicted by displacement of interior wall is evident. Wheeler & Gray photograph.

Ground movements displaced the transverse precast shear wall on line 3.3 (fig. 2) approximately 4 inches in a north-south direction, inflicting severe damage to the exterior precast panels connected to this wall (fig. 5). Most exterior concrete walls exhibited cracking in random directions.

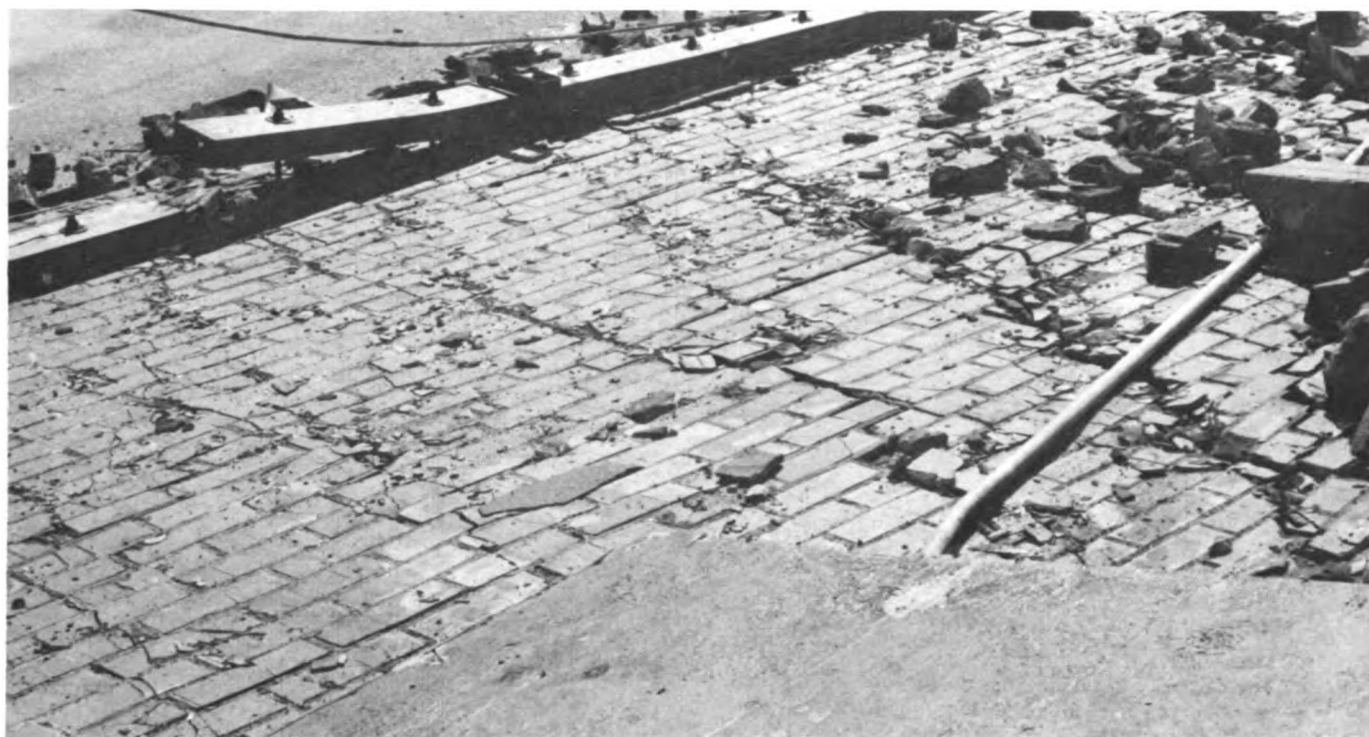
No major soil disturbance seemed to have affected the immediate area where this building was located. Only some minor ground cracking was visible. The rear (south) wall of the building collapsed after los-

ing lateral support at the roof (figs. 3 and 4). The nailing connecting the plywood roof to the ledger ripped through the edge of the plywood. Even though the ledgers did not fail, some of them showed serious splitting (fig. 5). The front wall of the building also was loosened from the roof but did not come down. Apparently, the wall returns at the entrance lobby helped to prevent the wall from collapsing. One of the side walls (west) moved out several inches at the front two bays, and the bolts connecting the ledgers to the wall pulled loose at the first bay only.

*Figure 3.—Bell Metrics. South wall of building on ground after collapse. Wood ledger still attached to wall in upper part of photograph. J. F. Meehan photograph.*

This structure was rebuilt to preearthquake conditions including some minor changes that were requested by the Los Angeles City Building Department. One of them was the addition of steel straps bracing from rebuilt walls to roof members (fig. 2, details 1 and 2). The other was the use of  $\frac{1}{2}$ -inch plywood with heavier nailing for that section of roof that collapsed (fig. 1).

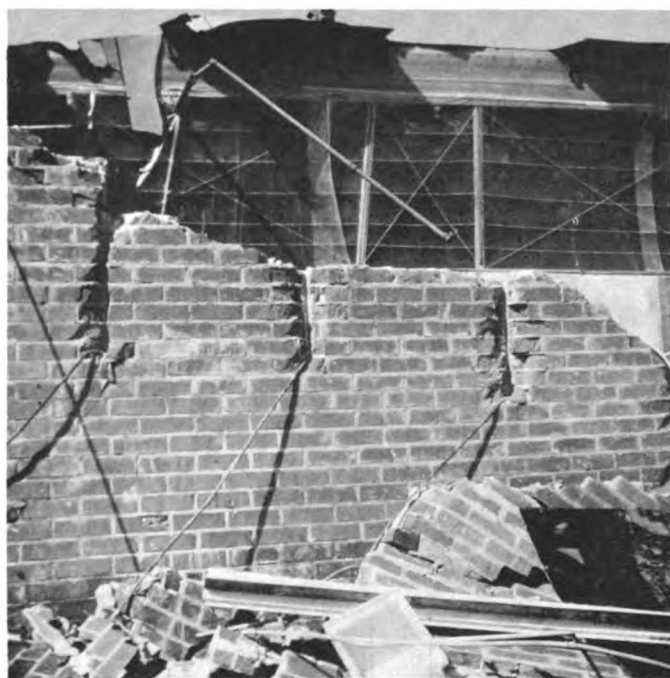
*Figure 4.—Bell Metrics. South wall collapsed. Note vertical reinforcing torn from brick wall. J. F. Meehan photograph.*

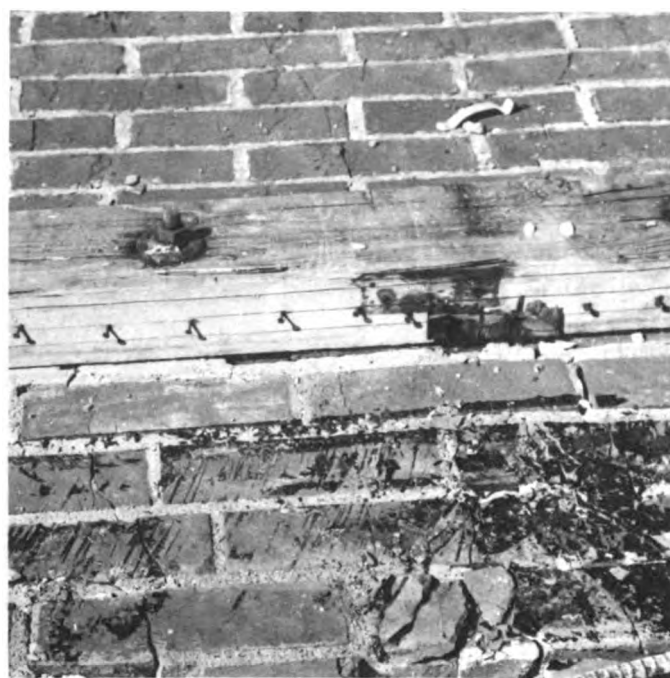
*Figure 5.—Bell Metrics. Closeup of wood ledger still attached to wall after collapse. Note nails in ledger. J. F. Meehan photograph.*

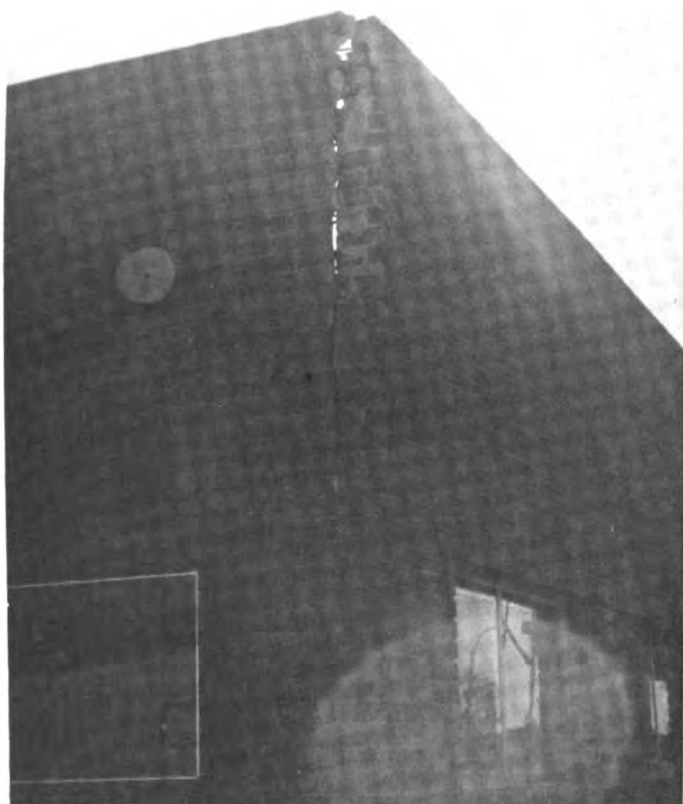
At the northeast corner of the building, walls separated, bricks from the upper portion broke and fell, and a pronounced crack appeared in the middle height of the wall (fig. 6). Anchorage between glued laminated girders and masonry pilaster was lost when the upper 2 feet of masonry developed severe cracking and, in some cases, spalled off (fig. 7).

Figure 6.—Bell Metrics. Northeast corner. Note separation.  
Bell Metrics photograph.

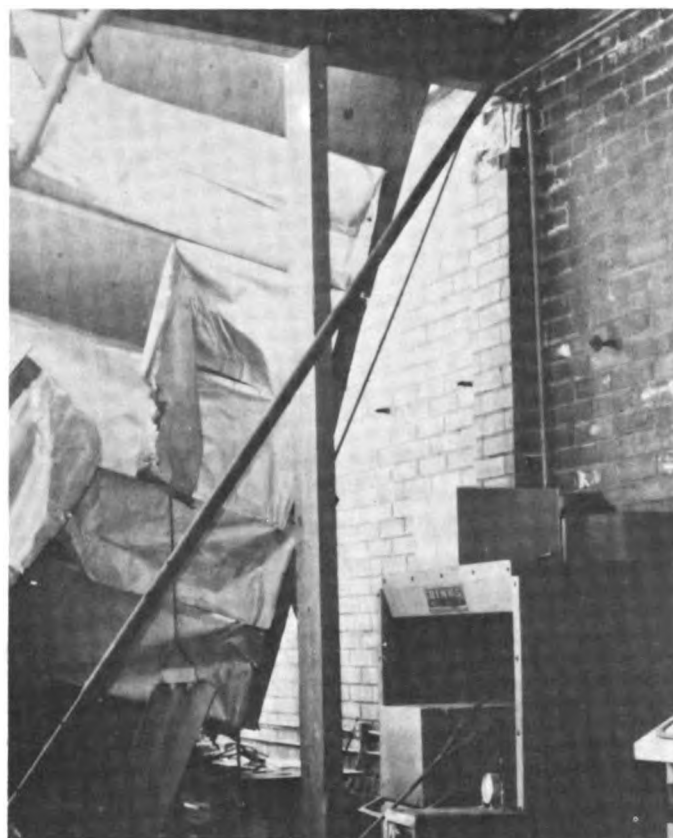
Figure 7.—Bell Metrics. West wall, with top of brick pilaster spalled off. Temporary repairs showing under girder. Bell Metrics photograph.

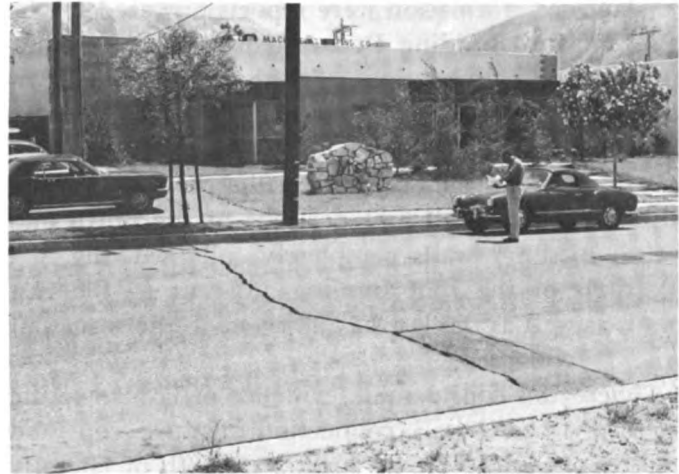
This general area was disturbed by surface effects of ground faulting. At this particular site the soil disturbance consisted of several tension-type cracks running roughly in an east-west direction (fig. 2). In some cases the building floor slab was cracked in the same manner (fig. 3).

Figure 2.—M&L Machine Shop. Front of building. Typical tension crack through street. Wheeler & Gray photograph.

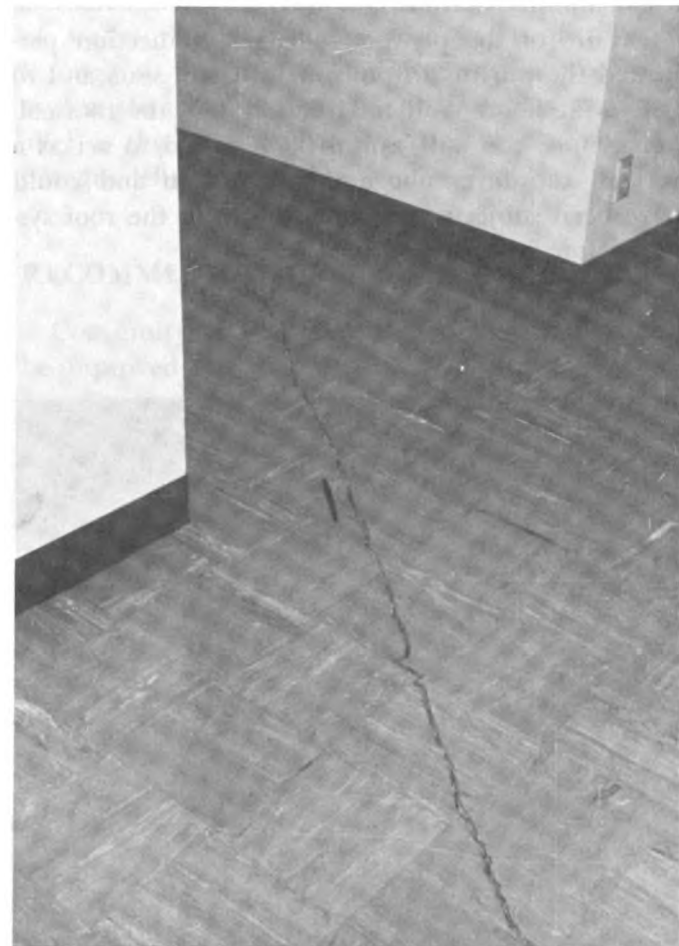
Figure 3.—M&L Machine Shop. Floor slab crack through office area. Wheeler & Gray photograph.

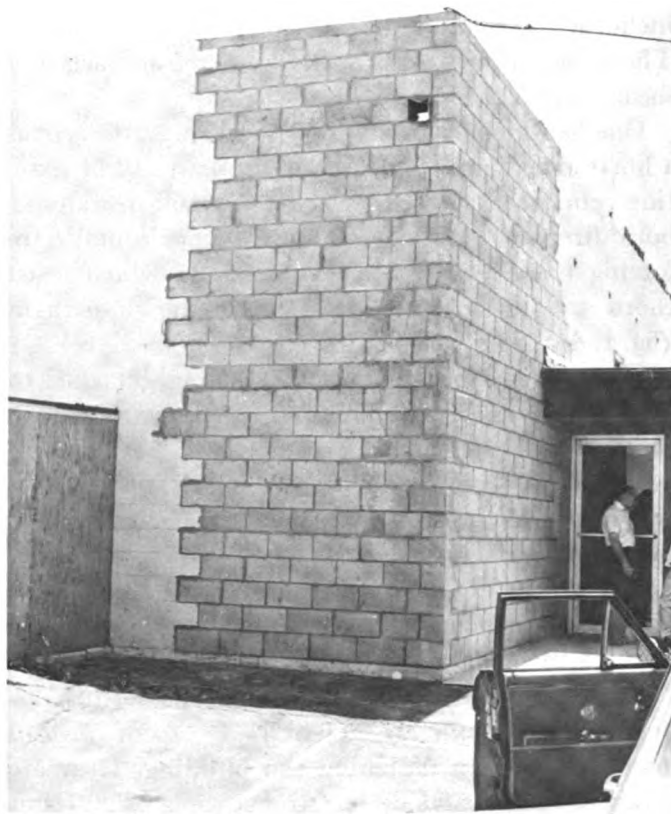
Figure 5.—M&L Machine Shop. Walls separated several inches at this corner. Walls were partially rebuilt (see fig. 4). Wheeler & Gray photograph.

Wall corner separations could be the result of a concentration of horizontal reinforcing at the tops of walls, rather than a more even distribution throughout the full height. Corner damage probably was caused by movements of the roof diaphragm parallel to the shear walls, as well as by excessive diaphragm deflections.

Damaged masonry walls were removed to undamaged areas and rebuilt to their original conditions. Tops of masonry pilasters were repaired where they were cracked and spalled.

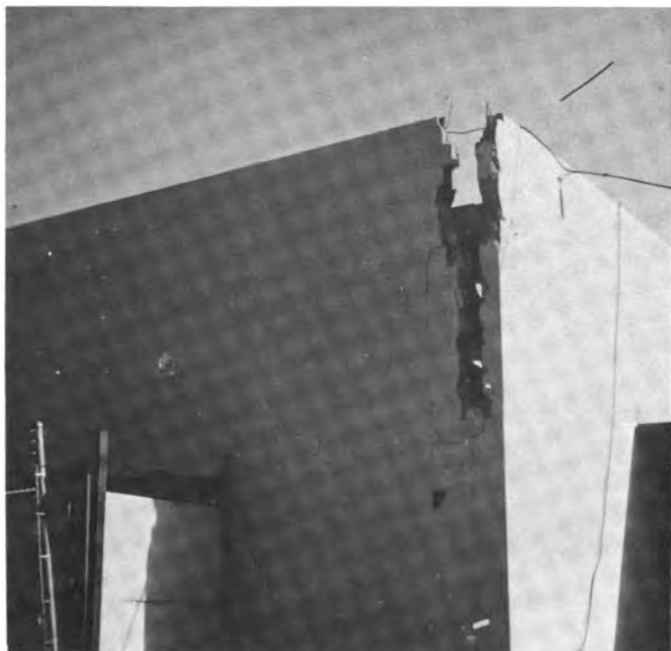
Figure 4.—M&L Machine Shop. Northwest corner. D. F. Moran photograph.

of damage information were reports prepared by the Los Angeles Building Department engineers, photographs, and conversations with the owner. Wall corner damage and corrective repairs are shown in figures 4 and 5.

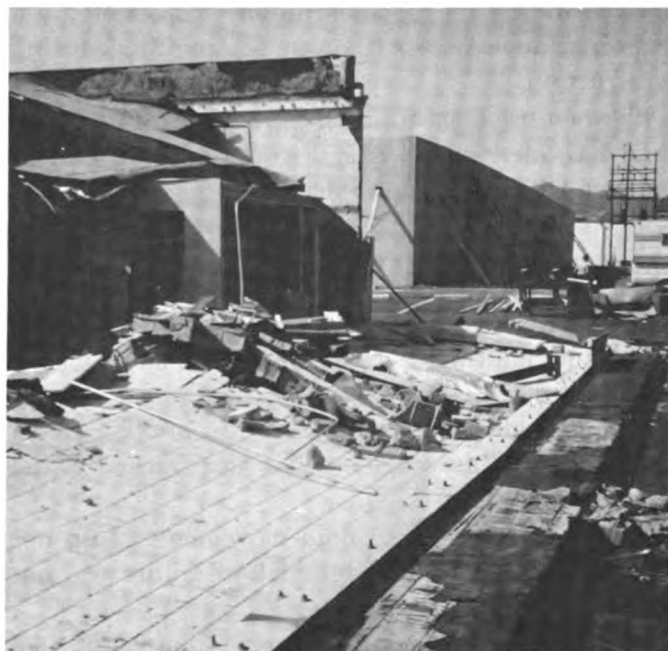
Heaviest damage occurred in the shop area where the entire east wall and portions of the north and south masonry walls completely collapsed (fig. 6). Portions of the roof framing adjacent to the east wall, as well as the last bay adjacent to the west wall (fig. 7), collapsed.

There was considerable evidence of failure of the roof plywood-to-wall connection. Failure consisted mostly of plywood nails pulling through or laterally out of the sheets. In a few cases nails pulled from ledgers, and some ledgers split horizontally along the upper line of bolts. Several sheets of plywood remained attached to the ledger, but nailing failed at the first joint inward from the wall.

Failure of the plywood-to-ledger connection permitted the purlins to pull out of their seats and to fall to the floor. Wall collapse followed the roof collapse, since the wall would be required to act as a vertical cantilever above the floor slab and could have been subjected to pounding from the roof system before failure.

Figure 6.—M&L Machine Shop. Rear (east) collapse. D. F. Moran photograph.

In the areas where the roof was damaged or separated from the masonry walls, joist anchors or steel straps were added to anchor the masonry walls to the roof.

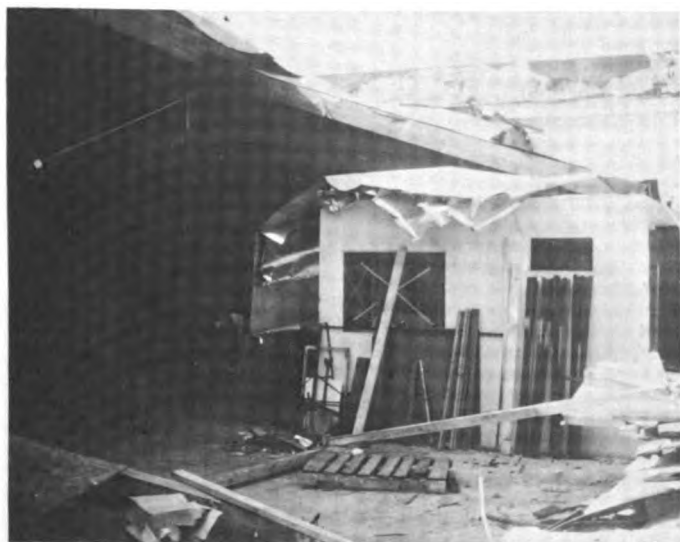
Figure 7.—M&L Machine Shop, looking north. Collapsed roof area.  
D. F. Moran photograph.

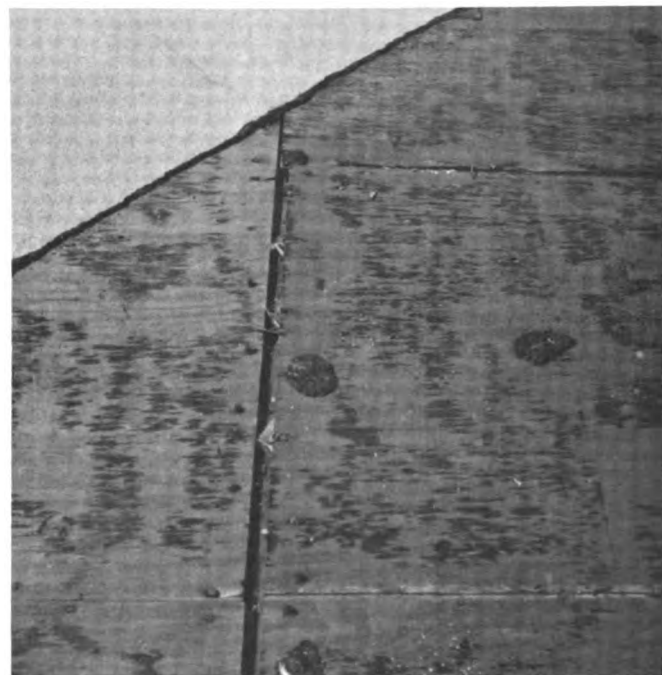
A survey of structural damage to the building showed several types of damage and collapse. The principal cause of collapse was failure of the plywood roof diaphragm connection to the walls. Diaphragm failure consisted of nails pulling through plywood sheets or out of wood ledgers. Some ledgers split horizontally along the upper bolt line. There was some evidence of distress in the roof diaphragm in the area of the reentrant corner (fig. 5). An examination of the outside of the building showed no

Figure 5.—Vector Electronics. Note spreading of roof sheathing over line 6 near reentrant corner. Sheets had been closely butted prior to earthquake. Wheeler & Gray photograph.

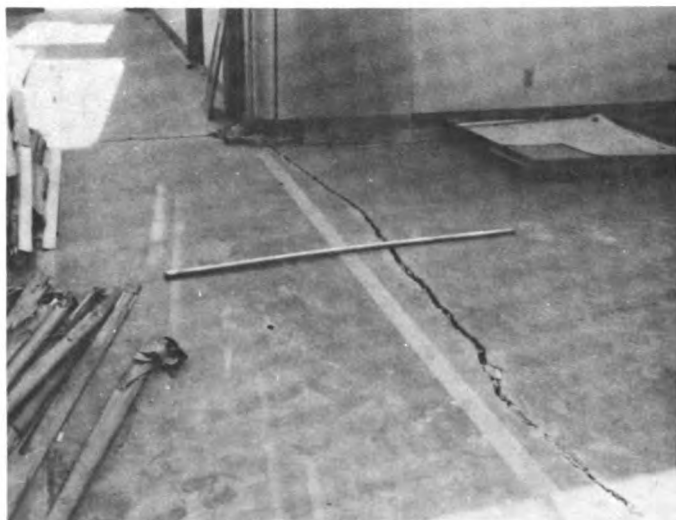
*Figure 6.—Vector Electronics. Typical floor slab cracking. Wheeler & Gray photograph.*

evidence of vertical displacement. Interior floor slabs showed numerous east-west cracks, which varied up to an inch in width but with minor differential settlement across the line of fracture. A series of cracks, generally in an east-west direction and corresponding to the floor slab cracks, was observed in the pavement in Gladstone Avenue. Typical slab cracking is

shown in figure 6. This cracking or spreading was responsible for stretching the building approximately 6 inches in a north-south direction.

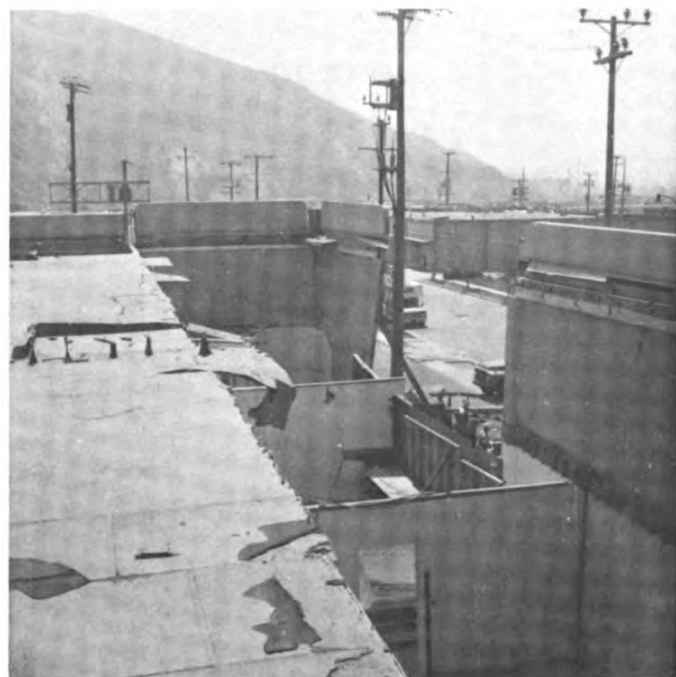
*Figure 7.—Vector Electronics. Collapse of roof after connection to wall ledgers failed. Two panels fell to ground on west wall. Wheeler & Gray photograph.*

The majority of wall panels on the south and east sides of the building separated from the roof diaphragm, causing the supported roof members to fall to the floor as described above (fig. 7). Wall panels at the southwest corner are shown leaning outward in figure 8. Two panels on the west side fell completely to the ground, and the balance of the dis-

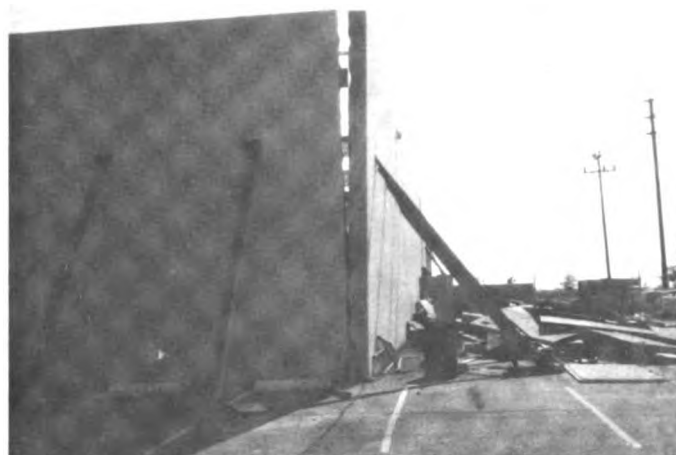
*Figure 8.—Vector Electronics. Wall panels leaning outward at southeast corner of building. Shoring has been installed for safety reasons. Wheeler & Gray photograph.*

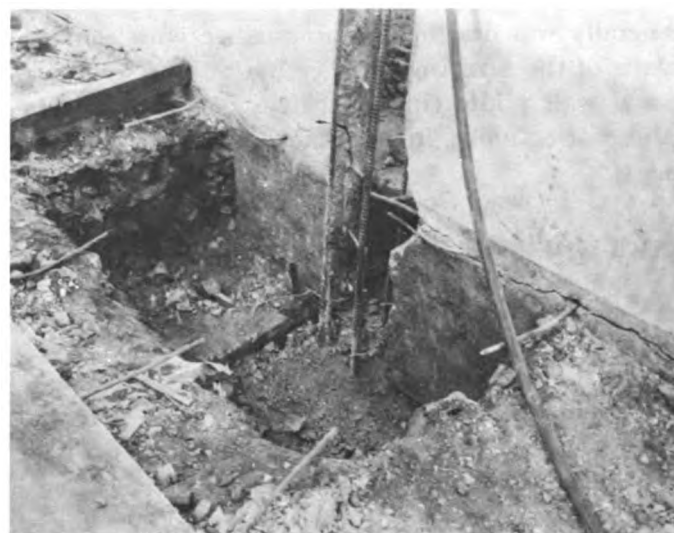
*Figure 9.—Vector Electronics. East wall. Note horizontal crack at floorline. Floor slab has been removed and earth excavated at top of footing. Wheeler & Gray photograph.*

placed panels remained upright, being restrained by the footing pads and floor slab dowels after the roof was separated. Cracking of wall panels and poured-in-place columns at about the ground line, due to vertical cantilever action, was widespread (fig. 9). Evidence of foundation failure could not be found.

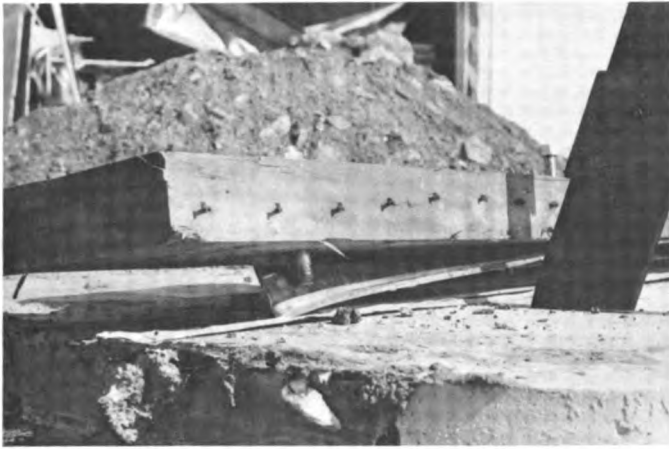
Figure 10.—Vector Electronics. View of wall ledger at collapsed panel of west wall. Note bent perimeter nails used to connect roof sheathing and shallow embedment of expansion-type concrete anchors used. J. F. Meehan photograph.

Due to cantilever action, considerable wall and column cracking occurred after failure of roof-to-wall connections. Expansion-type anchors, used in lieu of cast-in-place anchor bolts in some locations to attach wood ledgers to walls, pulled out (fig. 10). It was observed that these expansion anchors were embedded only slightly over 1 inch for  $\frac{3}{4}$ -inch-diameter anchors.

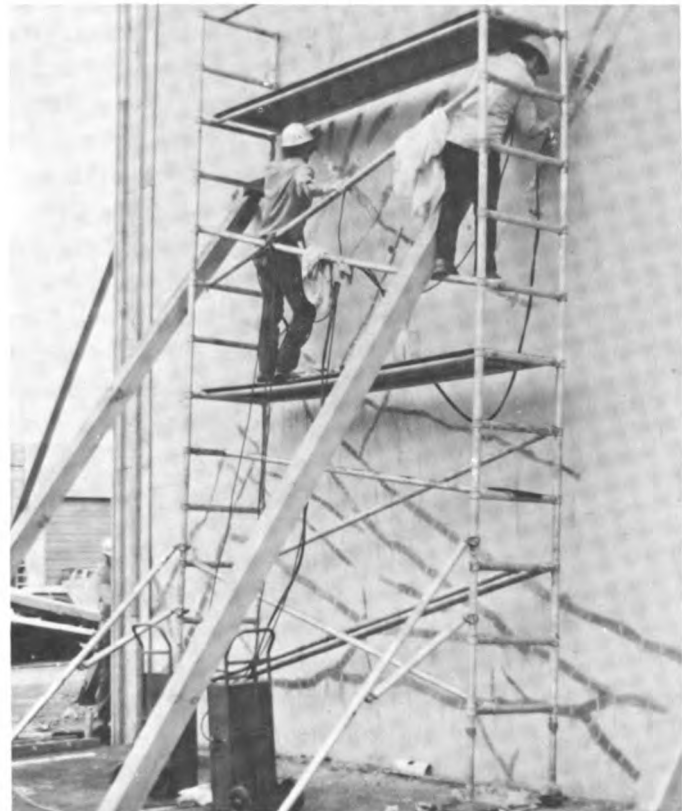
Figure 11.—Vector Electronics. Wall panels not too severely cracked were injected with epoxy as shown. Tests were made to insure penetration and effectiveness of repair. Adhesive Engineering Company photograph.

Remedial repairs were undertaken after a consulting engineering firm, engaged for the repair work, had re-analyzed the structure. The principal repairs consisted of epoxy injection to seal wall cracks (fig. 11); strengthening diaphragm-to-wall ties by addition of strap ties bolted through the wall and connected to roof framing; welding chord reinforcing between the panels to provide for continuity; strengthening miscellaneous roof-beam connections; and adding pipe columns at certain exterior wall locations to carry vertical loads. The plywood roof sheathing adjacent to the walls was rebuilt with  $\frac{5}{8}$ -

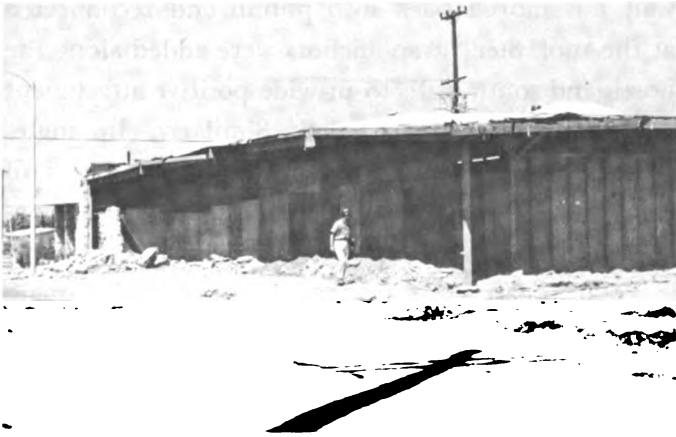
The severe soil upheaval cracked the floor slab at several locations and resulted in sufficiently serious damage to the north and east walls to require their replacement (fig. 2). The northern 20 feet of the

Figure 2.—Wendell Machine Shop. North and east elevations of building. Damaged walls have been removed and will be rebuilt. Wheeler & Gray photograph.

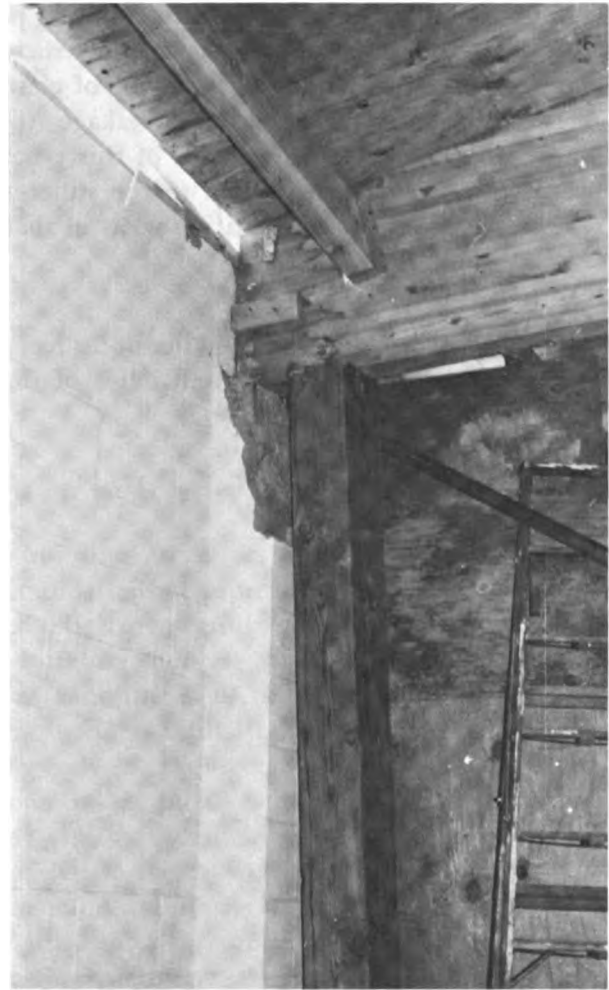
Figure 4 shows separation of the glued laminated roof girder from the reinforced concrete block pilasters at the east and west walls. Severe spalling occurred in the upper portion of the pilasters when the forces exceeded the capacity of the connection (fig. 1, section C-C).

Figure 4.—Wendell Machine Shop. Pilaster located at west wall. Damage to upper portion at junction with glued laminated girder. Shoring of girder is still in place. Wheeler & Gray photograph.

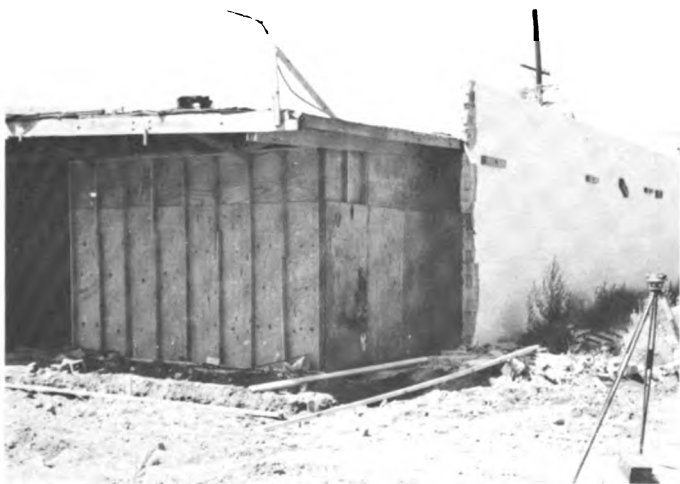
west wall also was affected by the ground motions. Severe cracking occurred, making it necessary to replace that portion of the west wall (fig. 3). The remainder of the west wall was pushed 2 inches out of plumb, but remained in reparable condition.

Figure 3.—Wendell Machine Shop. Northwest corner of building. Walls to be replaced have been removed. Wheeler & Gray photograph.

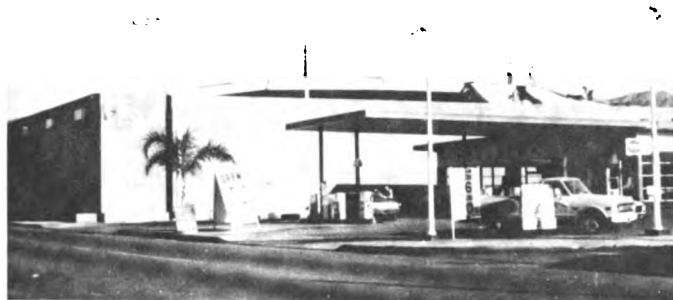
Figure 2.—Bennett Industries. Before repair work. Note open area at top of east wall. Rudy Gunnarson photograph.

Damage was limited primarily to the east wall (figs. 2 and 3), a part of which was torn loose from the roof.

Discussions with building department personnel indicate the partial cause of damage at this particular point was heavy rolls of paper falling against the wall. The paper is reported to have been stacked in a storage area adjacent to the wall.

The replacement cost of the structure, prior to the earthquake, can be estimated at about \$12 per square foot, or a total cost of \$495,000. Repairs to the damaged wall, estimated at about \$10,000, consisted of replacement of damaged material to its preearthquake condition.

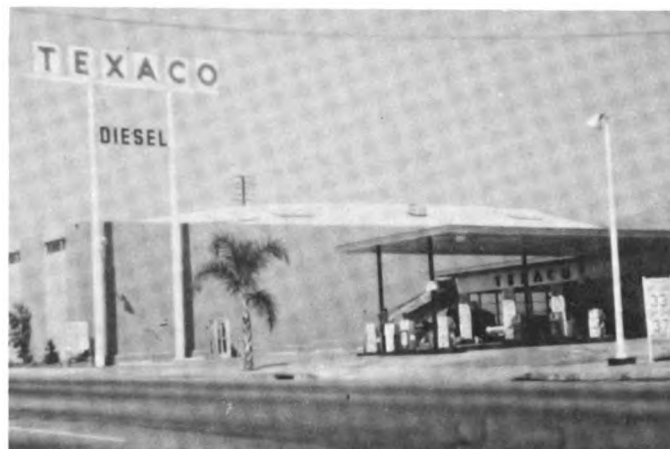
Figure 3.—Bennett Industries, looking west, after repair work. Rudy Gunnarson photograph.

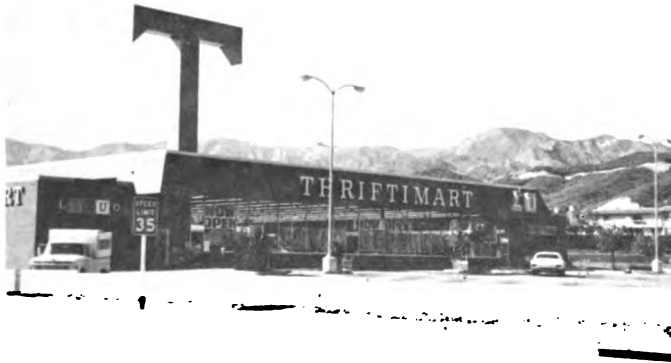
The north wall has a masonry section at each corner, about 35 feet long at the east end and about 29 feet long at the west end. These wall segments, along with the south wall, resist east-west seismic forces and are tied together by tapered steel girders that act as chord and collector members for the roof diaphragm (figs. 1 and 2). One of the girders is connected to the east wall segment by three No. 7 reinforcing bars that are welded to the web of the girder and extend (horizontally) about 3 feet 6 inches

Figure 2.—Thriftmart Market. Front (north) wall. Note masonry wall segments at each corner. J. Kesler photograph.

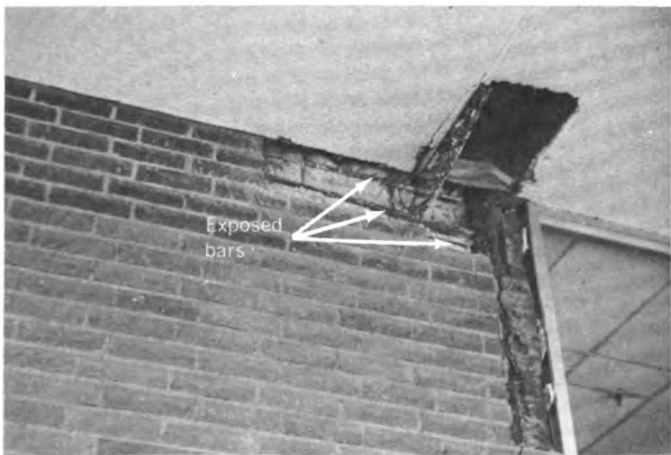
Figure 3.—Thriftmart Market. Strut connection to brick shear wall. Exposed are three No. 7 bars about 14 feet long. J. Kesler photograph.

into the masonry wall (fig. 1, section C-C). The bars lap with three No. 7 bars, placed at a lower elevation, that extend about 14 feet along the wall. This connection pulled loose, spalling the brick away from the length of the three No. 7 welded dowels, and vertically along the edge of the wall where a pipe column is embedded to support the vertical load of the girder (fig. 3). The failure appears to have been caused by a combination of bond and shear overload at the connection. Since the three continuous bars were placed below the welded dowel bars, the total load was transferred by shear through a net section of the wall.

Using the code seismic force level, the force at the connection, assuming half the tributary load went to each of the two wall segments, would be about 18,000 pounds; shear in the wall, assuming 3 feet 6 inches effective length, would be about 50 psi. The bond stress on the three bars would be 53 psi. These figures are approximate only because of the unknowns involved with relative stiffnesses of walls, struts, connections, direction of forces, and other factors that would affect distribution. From this analysis, it is evident that a connection failure should not occur until actual force levels reached several times the code force level. The damage was repaired by raising the three long bars and welding them directly to the three dowels. A continuous stress path thus was obtained, providing uniform force distribution over a longer length of wall.
